Tideflex® Mixing System (TMS) Solves Icing Problem For Standpipe Located in Ontario, Canada

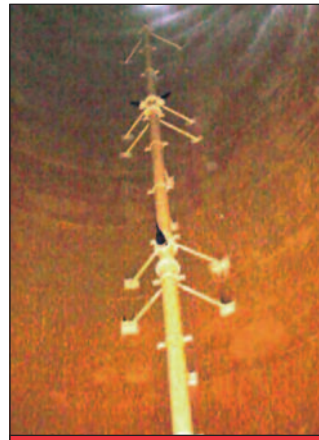
TMS Vertical Riser with Tideflex® Diffuser Nozzles Installed in Mono Mills

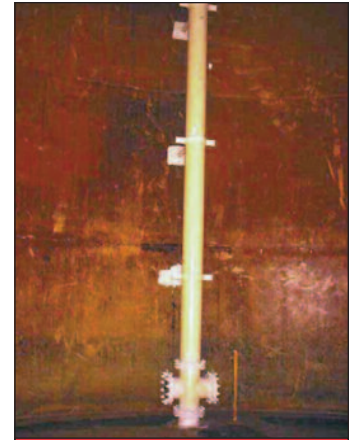
TMS Waterflex® Outlet Check Valves Installed in Mono Mills

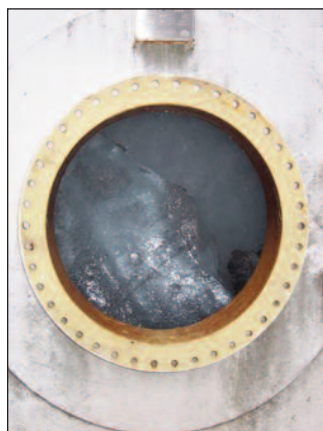
View of Ice Through Shell Hatch in Tank

In May, when the tank had been drained, a 30' diameter by 10' deep slug of ice was still in the tank. The ice, which had developed the previous winter, took an additional \$27,000 and two weeks for a contractor to remove.

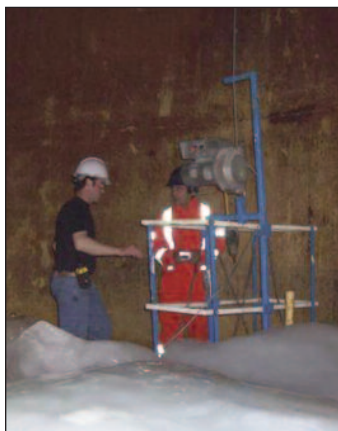
Contractors Working to Remove Ice From Tank

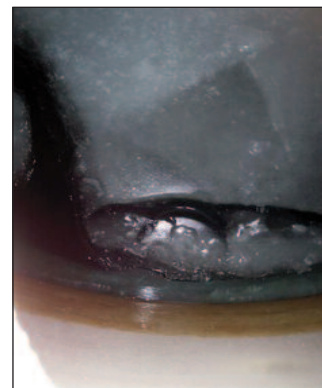
Only Slush and a Thin Layer of Ice Developed in Tank After TMS Installation

After the TMS was installed, videos were taken from the roof hatch showing turbulence on the water surface during filling even when the tank was near full. The tank was inspected the following March to observe level of ice build up. The Region of Peel reported a drastic reduction of ice formation with only minor patches of slush and thin ice. The TMS prevented an ice layer from freezing solid across the water surface.

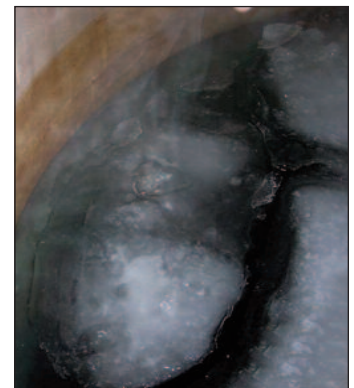
TMS Prevents Ice From Freezing Solid in Mono Mills Standpipe
